# RESULTS OF THE SECOND U.S. MANNED SUBORBITAL SPACE FLIGHT JULY 21, 1961

**MANNED SPACECRAFT CENTER  
NATIONAL AERONAUTICS  
AND SPACE ADMINISTRATION**

Page
FOREWORD.....	iii
1. INTRODUCTION.....	1
By Robert R. Gilruth, Director, NASA Manned Spacecraft Center.	
2. SPACECRAFT AND FLIGHT PLAN FOR THE MERCURY-REDSTONE 4 FLIGHT.....	3
By Jerome B. Hammack, Mercury-Redstone Project Engineer, NASA Manned Spacecraft Center.

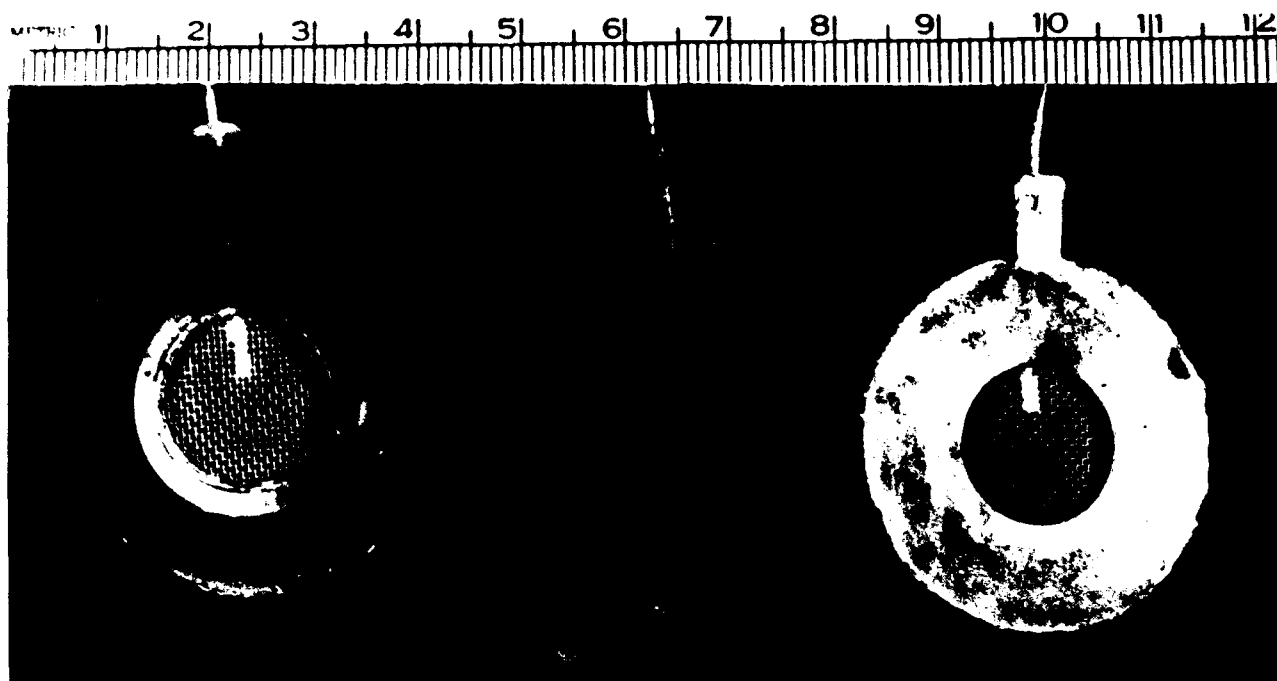
FIGURE 5-1. Three views of a typical electrocardiograph floating electrode as used in Project Mercury. The surface of the electrode applied to the skin (right) is first painted with adhesive and then filled with bentonite paste.

The next step in the preparatory procedures was the application of the biological sensor harness (figs. 5-1 and 5-2). This harness is described in detail in reference 2. The only difference between the sensors used in MR-3 and MR-4 flights was an alteration of the respiration sensor housing for the MR-4 flight to accommodate the microphone of different configuration used in the later flight. The surface of the electrode next to the skin is prepared with an adhesive material identical to that found on conventional adhesive tape (elastoplast adhe-
